A Field Evaluation of the Use of Small Trail Tractors to Maintain and Construct OHV Trails on National Forests in California

USDA-Forest Service, Pacific Southwest Region

Roger Poff

Natural Resources Professional Services Contract 53-91S8-NRM-08 Natural Resources Management Corporation, Prime Contractor August 22, 2001

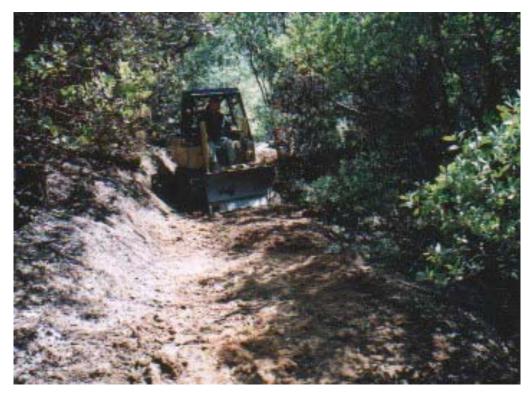
OHV traffic on single-track trails causes a berm to build up on the downhill side of the trail. During trail maintenance (with either a SWECO-type tractor or a mini-excavator) this berm may be pulled back onto the tread (see Appendix 1, Photo 1). Brush clearing may accompany this operation. This can give the appearance that the trail has been widened even though there has been no actual change in trail width. These trails often return to their single-track appearance within a few months as needles and leaves accumulate, and as OHV traffic defines a new tread.

Photo 1. SWECO 480 backblading berm. Note wider appearance of trail. Sled Ridge Trail, Upper Lake RD, Mendocino NF, 4/11/01.

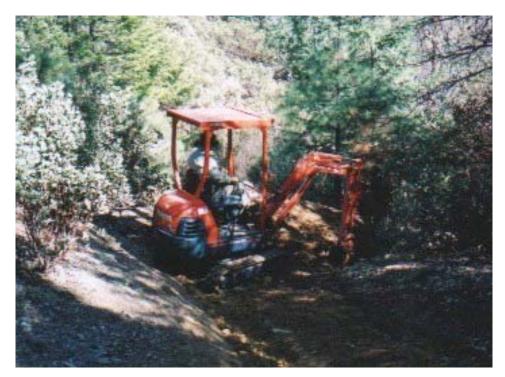
Photo 2. Kubota excavator (16-in bucket) cleaning out sediment trap. Sled Ridge Trail, Upper Lake RD, Mendocino NF, 4/11/01.

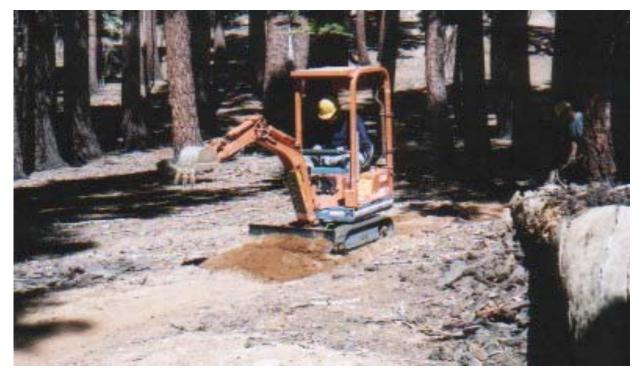
The need for maintenance varies considerably with trail gradient, soil type, and amount and type of use. Some trails will require annual maintenance. However, we did observe one single-track trail, constructed with a SWECO trail tractor and drained by outsloping and reverse grade rolling dips, that probably can be maintained indefinitely by hand; this trail gets heavy use, but 80% of the use is by mountain bikes. We observed OHV trails on very fine sands derived from granitics that require annual maintenance with a mini-excavator (see Appendix 1, Photos 3 and 4).

Photo 3. Kubota excavator (8-in bucket) blading trail. Cannell Meadows RD, Sequoia NF, 6/1/01.

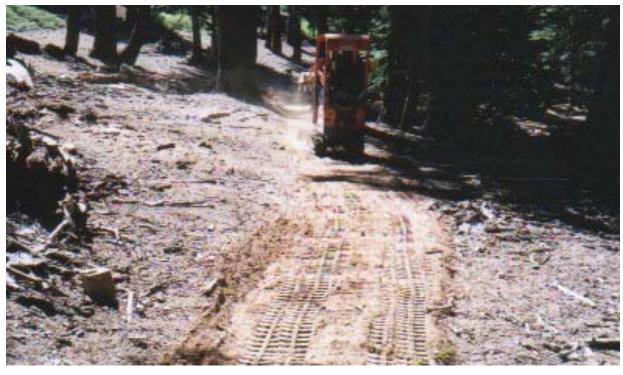
Photo 4. Trail bladed with Kubota mini-excavator. Cannell Meadows RD, Sequoia NF, 6/1/01.

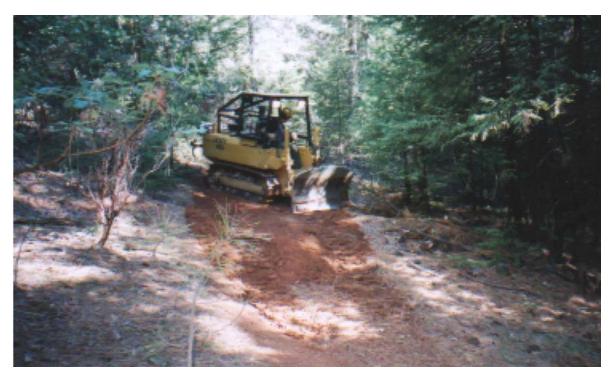
Photo 5. SWECO 450 constructing OHV rolling dip on old road. Georgetown RD, Eldorado NF, 4/30/01.

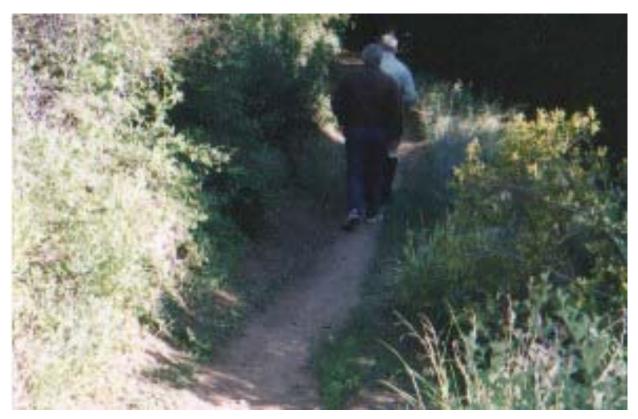
On the trails we observed and rode, the primary cause of trail widening appears to be ATV traffic, not maintenance with SWECO-type trail tractors. We observed numerous single-track trails constructed and/or maintained with SWECO-type trail tractors (see Appendix 1, Photos 6, 7, 8, 9).

Photo 7. Single-track trail constructed and maintained with SWECO 450. Santa Clara-Mojave Rivers RD, Angeles NF, 5/3/01

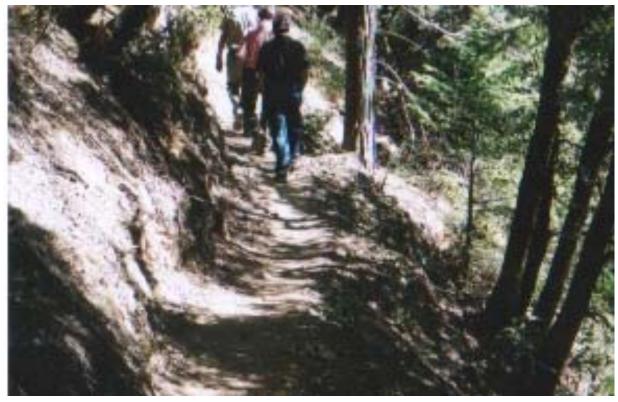
Photo 8. Single-track trail constructed with SWECO trail tractor. Downieville RD, Tahoe NF, 6/13/01.

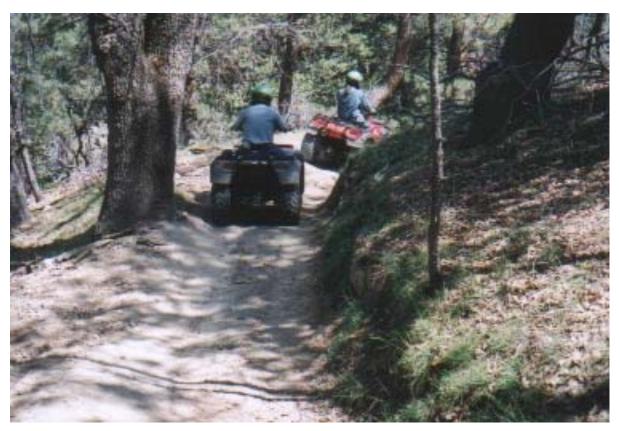
3. ATV use, not maintenance by SWECO-type trail tractors, is the primary cause of trail widening.

Photo 9. ATVs on multi-use trail maintained with SWECO trail tractor. Note wider tread. Mountain Top RD, San Bernardino NF, 5/1/01.

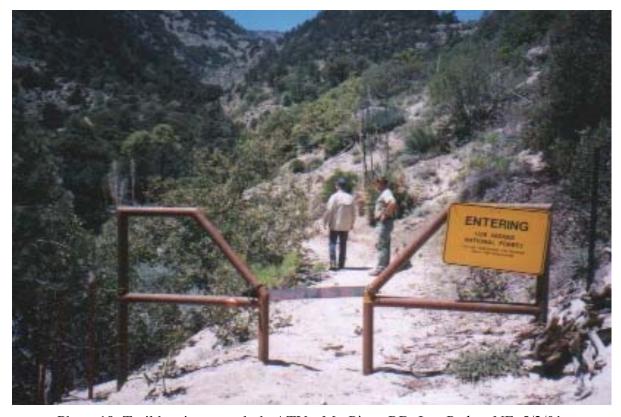
Photo 10. Trail barrier to exclude ATVs. Mt. Pinos RD, Los Padres NF, 5/2/01.
